November 9, 1965

December 6, 1965

REPORT TO THE PRESIDENT
BY THE FEDERAL POWER COMMISSION
ON THE POWER FAILURE IN THE NORTHEASTERN UNITED STATES AND THE PROVINCE
OF ONTARIO ON NOVEMBER 9-10, 1965

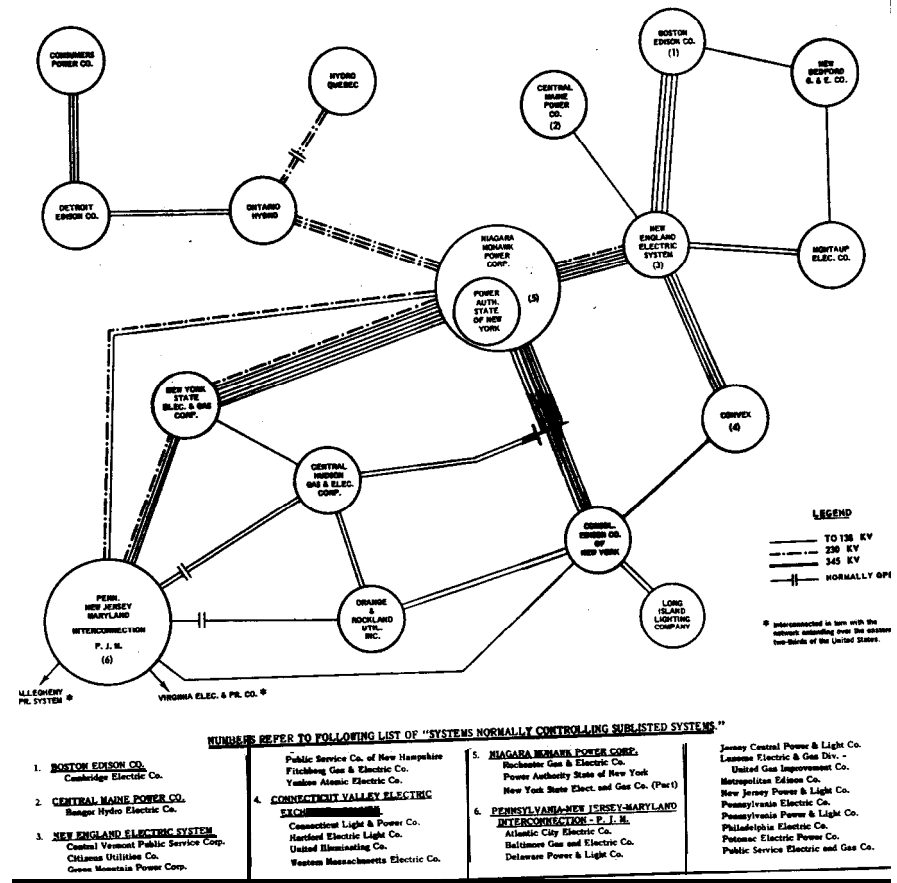
EXHIBIT I-C

LOAD CONTROL AREAS AND POWER SYSTEM INTERCONNECTIONS CANUSE AND P.J.M.

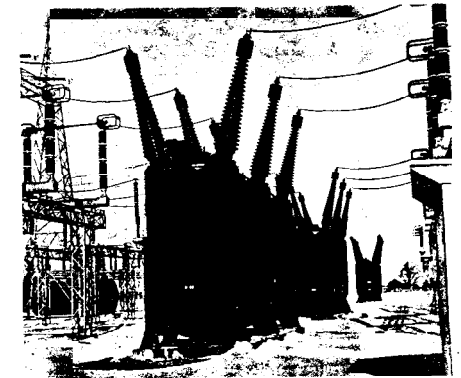
Exhibit I-K. These oil circuit breakers at the Clay Substation of Niagara Mohawk Power Corporation were activated by the relays shown in Exhibit I-J, and opened the lines they serve about 3% seconds after the initial disturbance.

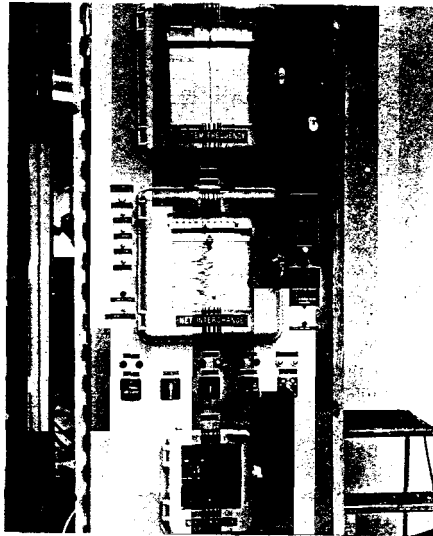
Exhibit I-R. These recording meters, at the Syracuse Area Control Center of Niagara Mohawk Power Corporation, give the system operators an

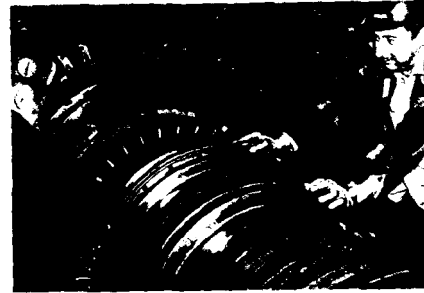
Exhibit III-C. When station service was lost at the Ravenswood plant of Consolidated Edison, oil pressure circulation to the bearings of the 1,000,000 Kilowatt Unit No. 3 was lost. The machine was taken off the line, but the bearings were damaged and the journal, shown above, was scored during the run-down period.

During the sudden shutdown Consolidated Edison lost 1,500,000 kw of generation because of damage to the bearings caused by the loss of power to the auxiliary equipment necessary to a safe shutdown of the generators. The Ravenswood Unit No. 3 burned out its main bearing because of a loss of oil pressure on the bearings when the auxiliary oil feed pump stopped at the time of the failure of the Power system. Damage to the journal is shown in Exhibit III-C. In addition, at other stations a large transformer as well as several motors and auxiliary equipment were damaged as a result of the shutdown. The loss of these key units extended the time required by Consolidated Edison to effect a restoration of service.
